INSPECTION OF THE SPACE SHUTTLE EXTERNAL TANK SOFI USING NEAR-FIELD AND FOCUSED MILLIMETER WAVE NONDESTRUCTIVE TESTING TECHNIQUES

S. Kharkovsky¹, F. Hepburn², J. Walker² and R. Zoughi¹

ABSTRACT

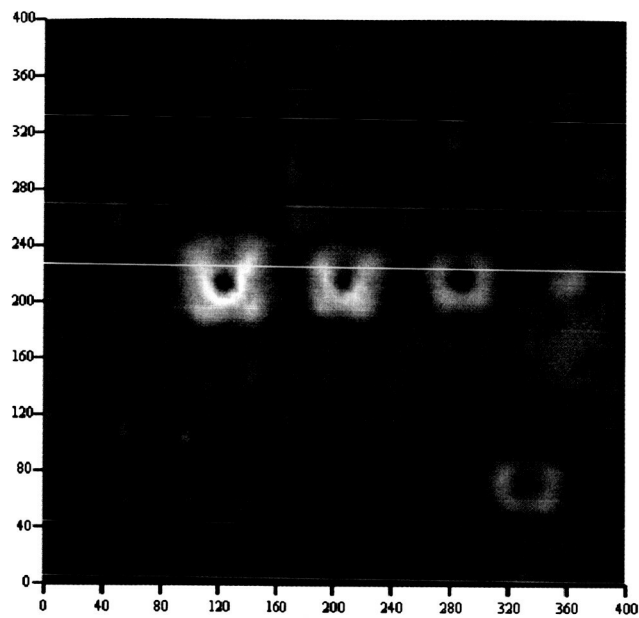
A 40 cm (15.7") by 40 cm (15.7") area of panel #1 was scanned using the lens and the small horn antennas, as shown in Figures 9 and 10, respectively. In Figure 9 the distance between the surface of the substrate and the lens was 25.4 cm (10"). In this image all eight anomalies are clearly detected. The square shape associated with all of these anomalies are also clearly indicated in the image. Four distinct bright spots are seen at the four corners of the unbond located at the lower left corner. These spots correspond to four small drops of adhesive that were used to adhere the unbond insert to the SLA surface. The dimensions associated with each anomaly in the image are very close to their actual dimensions. Throughout this image several superimposed diagonal lines are seen as well. These correspond to regions of the foam with slightly higher density and subsequently different dielectric properties.

In both images of this panel there are several indications (i.e., three around the upper right unbond). These may be due to the presence of small natural voids that may have been produced during the manufacturing of this panel. This fact may be validated in the future when and if this panel is dissected or imaged with a higher resolution system (intended future work).

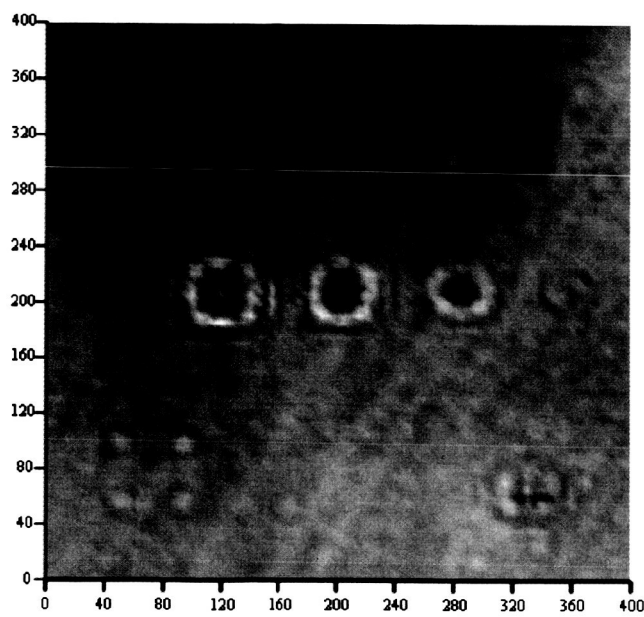
Figure 10 shows the image of this panel when the distance between the small horn aperture and the top surface of the foam sample was 0.6 cm (0.24"), putting the horn aperture distance to the top of the substrate at 10.6 cm (4.17"). When comparing the images in Figures 9 and 10, one can see much similarity between them. The dimensions of the embedded anomalies associated with their images closely correspond to their actual dimensions. Except for the upper central regions of the image, for the most part this image is more clear and sharp than the one shown in Figure 9. The four small drops of adhesive and the boundaries of the unbond associated with them are clearly visible in this image.

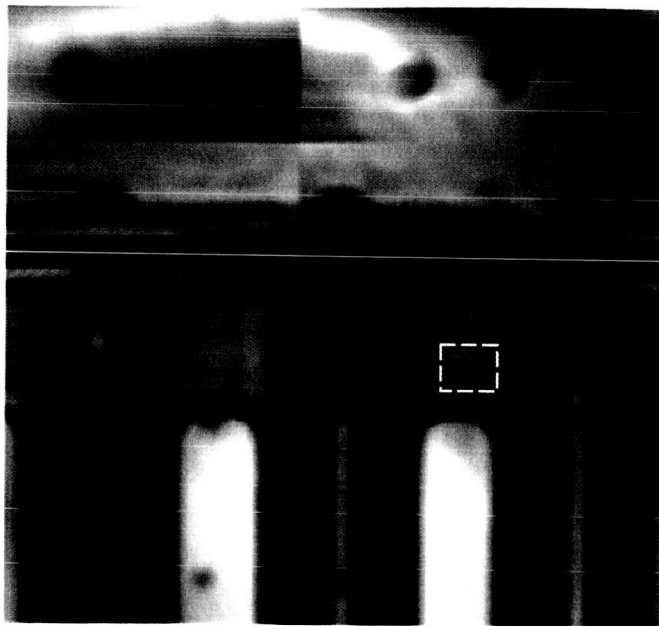
Figure 11 shows the image of this panel using the lens antenna at a distance of 25.4 cm (10”) from the substrate with the polarization vector parallel to the stringer axes. Due to the scanning size limitation associated with the scanning table, this image is a composite of four separate images that are augmented to produce the final image. The results clearly indicate the detailed structural features of the panel when compared to its picture shown in Figure 5. The three stringers, the flange, the three bolts through the flange, the bolts along the stringers, the stringer opening and the cut foam pattern between the stringers (see Figure 6) are all clearly visible in this image.

The two sets of three square rubber inserts and round foam void inserts are also clearly detected at the top of the image. The square shape of the rubber inserts (particularly the largest one) and the round shape of the foam voids can easily be deciphered from their respective images.

The flange is also clearly detected in addition to a long indication in the middle of the flange. This is the indication of the boundary between the two separate pieces of aluminum that are bolted together to produce the flange. The three bolts through the flange are also distinctly shown. The rubber and foam inserts under the bolt heads are not separately detected. However, a closer inspection of the bolt head images reveals that the bolt head with the rubber insert extending out from under it (on the left) has a wider image than the one with a small foam insert under it (on the right). The same is also true for the middle bolt head. On the other hand, there is no real indication of the rubber insert under the nut (on the left) when its image is compared with the other two nuts.

The two rubber inserts between the left and the middle stringers are detected since the rubber dielectric properties are more substantially different than the foam as compared to air and foam. The voids between the middle and the right stringers can barely be seen in the image with the smaller void having a much fainter intensity in the image (this void can be seen better in later images). The same can also be said for the rubber and foam inserts on the tops of the middle and right stringers. The rubber and foam inserts on the sides of these two stringers are not detected in this image. It must be noted that an additional and unexpected indication was detected between the upper portions of the middle and the right stringers, marked with the dashed square in Figure 11. This indication was more prominently detected using the small horn antenna, as will be shown later. It is believed that this is the indication of the presence of a natural void that was produced during the manufacturing of the panel. This fact may be verified by dissecting the foam to reveal the presence of this void. In the future we plan on imaging this panel at higher millimeter wave frequencies which should give more information about the nature of this indication.

Finally, one can clearly see indications in the centers of all three stringer openings (the dark curved features). However, a foam void was placed in the right stringer opening region and none in the other two. As a matter of fact the indication in the middle stringer opening is the strongest of all three. It turns out that during the manufacturing of this panel, three cavities were unintentionally produced in the foam directly above these three stringer opening areas. Additionally, the cavities in all three regions possess a distinct curved shape. Figure 12 shows a close up picture of the foam surface indicating these three cavities.

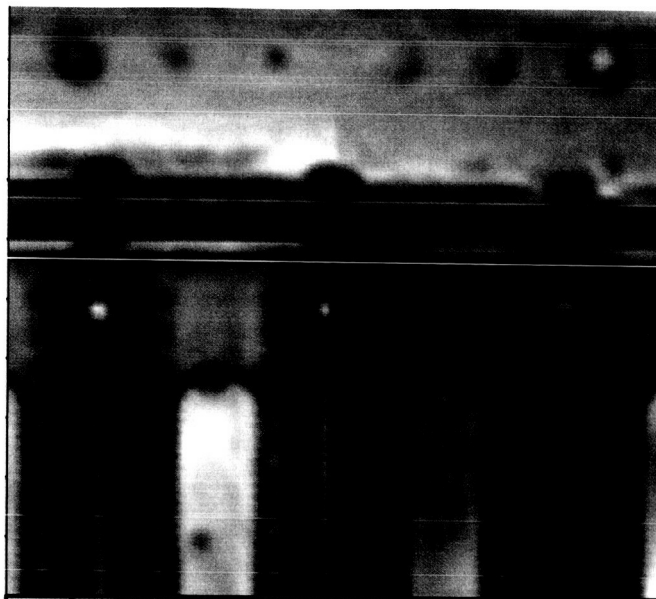
Figure 13 shows the image of this panel using the lens antenna at a distance of 25.4 cm (10") from the substrate with the polarization vector perpendicular to the stringer axes. Due to the scanning size limitation associated with the scanning table, this image is a composite of four separate images that are augmented to produce the final image. The bright line through the middle stringer and the slight misalignment in the middle of the flange and the bolt at this location are an artifact of augmenting these four images and is not an indication of embedded

anomalies. Similar to the image shown in Figure 11, with the exception of the inserts on the sides of the stringers and those under the flange bolts, all other inserts are detected, at least to some degree. The foam void between the middle and the right stringers are more clearly detected in this image. This is not a polarization effect and most likely has to do with the arrangement of the panel prior to imaging this section.

When compared to Figure 11, it is clear that at this polarization the images of the flange areas are clearer, revealing more of its structural detail. One may also see more indications of the inserts as they extend out from under the flange bolts at this polarization. The stringer opening regions are more vivid in this image as well. In this image, the horizontal terminating edge at the top of the stringers is somewhat more distinctly detected.

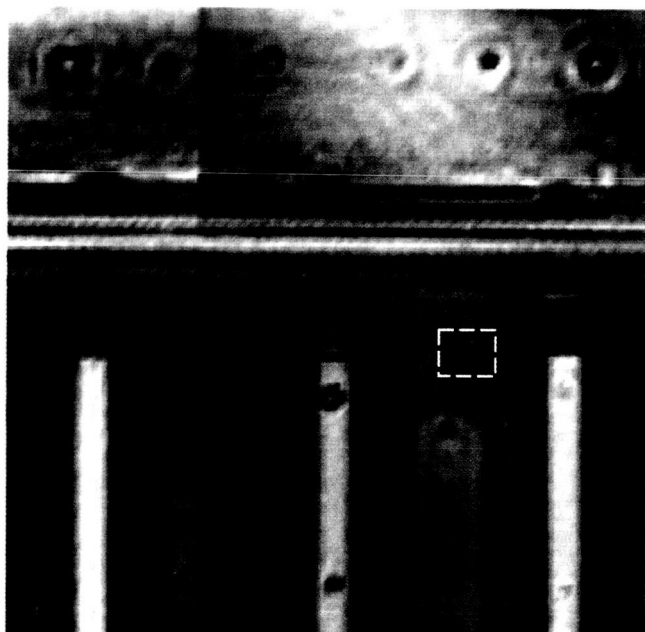
Figure 14 shows the image of this panel using the horn antenna at a distance of 10.5 cm (4.13") from the substrate with the polarization vector parallel to the stringer axes. This image is a composite of four separate images that are augmented to produce the final image. The line through the image and in the middle of the left and the middle stringers is an artifact of augmenting these four images and is not an indication of an embedded anomaly. This image shows all of the anomalies and features that were shown in the images using the lens antenna (Figure 11). However, due to the fact that during the scan some of the inserts and anomalies were at different distances from the horn aperture (in its near-field region), their indications are much more distinct than those in Figure 11. Examples of these are the foam inserts on top of the right stringer in which even the smaller foam insert is clearly detected and the foam inserts between the middle and the right stringers which shows the smaller foam insert better than its counterpart in Figure 11. The presence of the unintended void in the upper portion of the region between the middle and the right stringers is also more strongly sensed (shown by the dashed square). The stringer opening regions have a clearer image with the horn than with the lens. The strong indication in the center of the right stringer opening is due to the presence of the foam void placed there (see Figure 5) in addition to the natural cavity in the foam at this location. The presence of the cavities in the foam at the other two stringer openings is also detected but more consistent with the size and features of these respective voided regions (see Figure 12). The

square shape associated with the rubber inserts and the round shapes associated with the foam inserts in the top region of the panel are more clearly illustrated in this image than those using the lens antenna. Finally, it may also be argued that the presence of the rubber insert extending out from under the flange bolt caused more signal perturbation using the horn antenna than when using the lens antenna.

Similar to the two previous images of this panel, the presence of the rubber inserts and foam voids on the sides of the stringers was not detected with the horn antenna either. The stringer bolts were not as distinctly detected using the horn antenna since at that distance the spatial resolution associated with the antenna footprint is larger than that with the lens antenna.

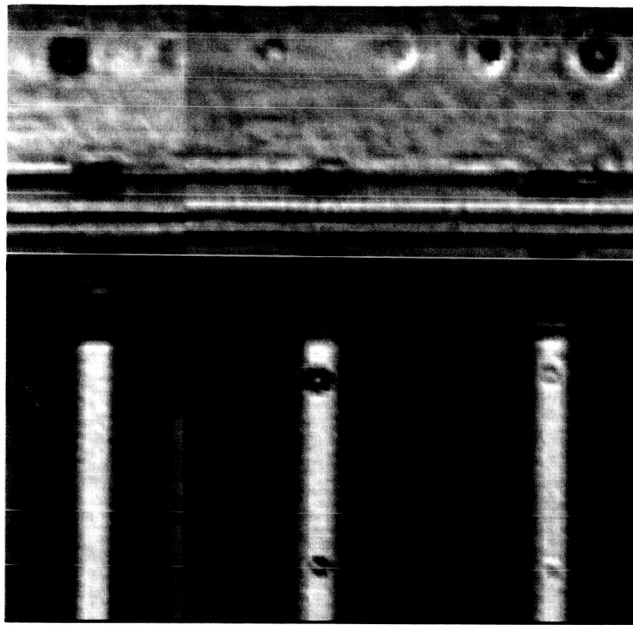
Figure 15 shows the image of this panel using the horn antenna at a distance of 10.5 cm (4.13”) from the substrate with the polarization vector perpendicular to the stringer axes. As in the previous case, many of the embedded inserts are clearly detected at this polarization. However, overall this image is less clear than its parallel polarization counterpart. The stringer opening regions do not clearly indicate distinct presence of the voids (embedded and natural) in the order of sizes they actually are.

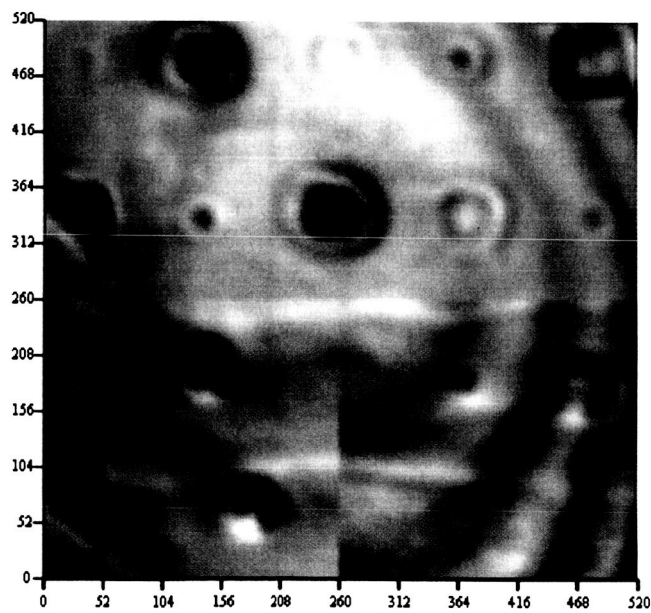
Figure 16 shows the image of this panel using the lens antenna at a distance of 45.7 cm (18”) from the substrate. This distance was used in this case since it produced better images of this panel. All of the embedded inserts at the substrate (as shown in Figure 8) corresponding to the top half of the image are distinctly detected showing their relative sizes. Moreover, the hollowness associated with the voids is visible through the slight shadows (i.e., the dark boundary indications) produced due to the fact that the corners of the panel were lifted up, as explained earlier (see Figure 7). The rings and halos around the voids and the unbonds are due

to the fact that at this distance the influence of the radiating beam sidelobes may have been more significant than at its designed focal length. The “big diagonal” void in lower left corner of this section is also clearly detected.

With the exception of three unbonds, the rest of the inserts are also detected when placed in the middle of the panel depth corresponding to the lower half of the image. It should be noted that the 1” and the 0.5” voids are shifted with respect to their positions shown in the schematic (see Figure 8) due to a manufacturing error. The three unbonds may at least be partially masked by the prominent rings, fringes, in this image, in particular in the lower right corner, which are artifacts of interference effects caused by the raised corners of the substrate. Consequently, the distance between the lens and the substrate varied throughout the sample producing these rings. The “little diagonal” void in the lower left corner of the image, is also detected.

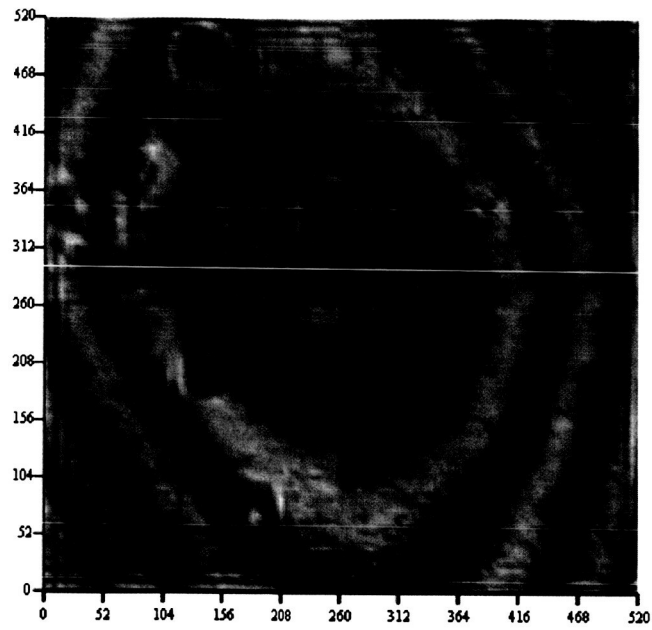
Figure 17 shows the image of this panel (composite of four separate images) using the horn antenna at a distance of 20.9 cm (8.24”) from the substrate. At this distance the footprint associated with this horn is substantially larger than that of the lens resulting in an image with an expectedly degraded spatial resolution. This fact is clearly shown in this image since primarily only the larger voids are detected. The larger unbonds at the substrate are detected but not those placed in the middle of the foam thickness. Some weak indication of the “big diagonal” void can be seen in this image but not of the “little diagonal” void. The superimposed ring pattern is also shown in this image due to interference effects caused by the raised corners of the panel. Overall, the results for this panel, when using the horn antenna, are not as good as when using the lens antenna due to better focusing capabilities of the lens.
